I-35 Traveler Information During Construction

Connected Work Zone Applications

FHWA Peer Exchange, November 15-16, 2022

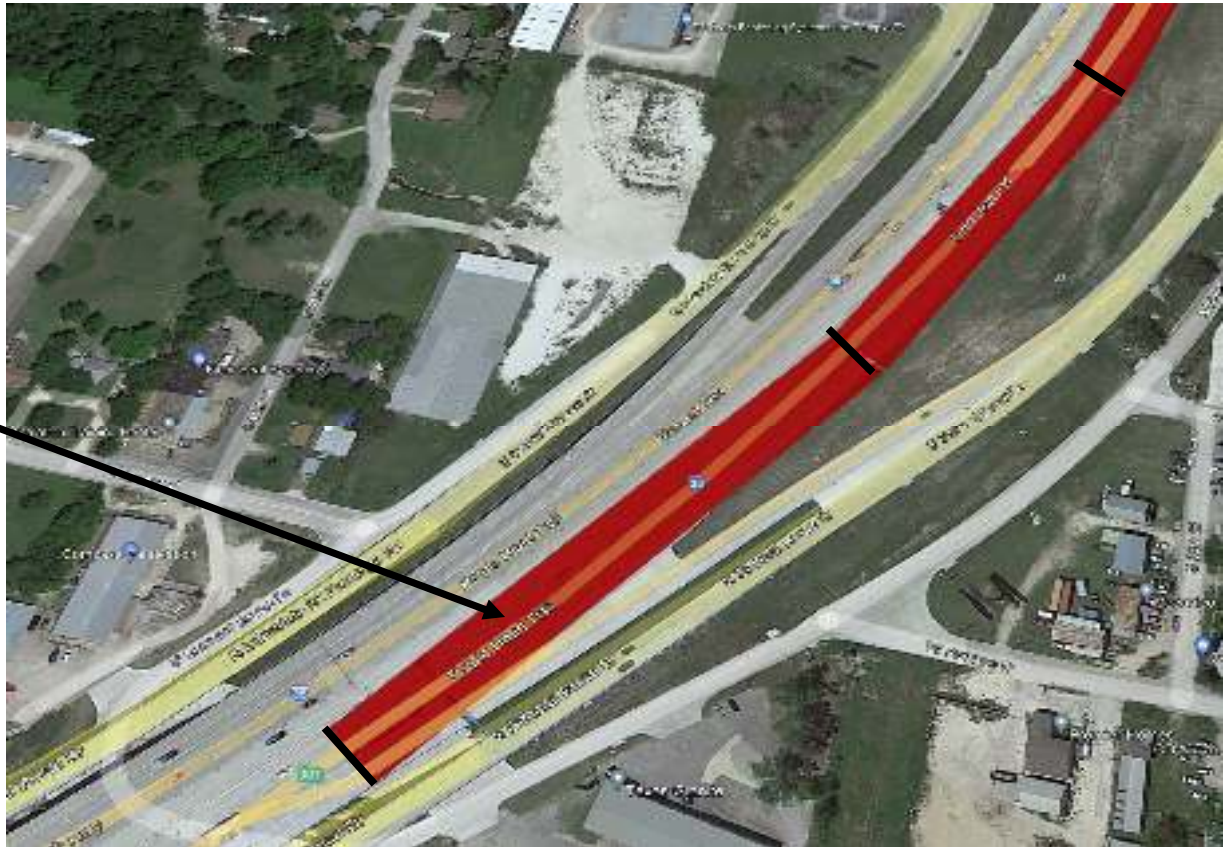
Approach Polygon for Work Zone Warning

OBU application generates a warning if a connected vehicle's

[position coordinates are within approach polygon]

AND

[heading is within a specified value for heading +/- tolerance]

- OBU received the appropriate RSM at the right location upstream of the lane closure.
- The generated warning message was occasionally lost. It typically occurred on curves when the connected vehicle got outside of the geo-fenced warning polygon.
- After making the following changes system worked as intended:
 - increased from 20 m to 25 m, and
 - revised the degree of +/- tolerance for headings

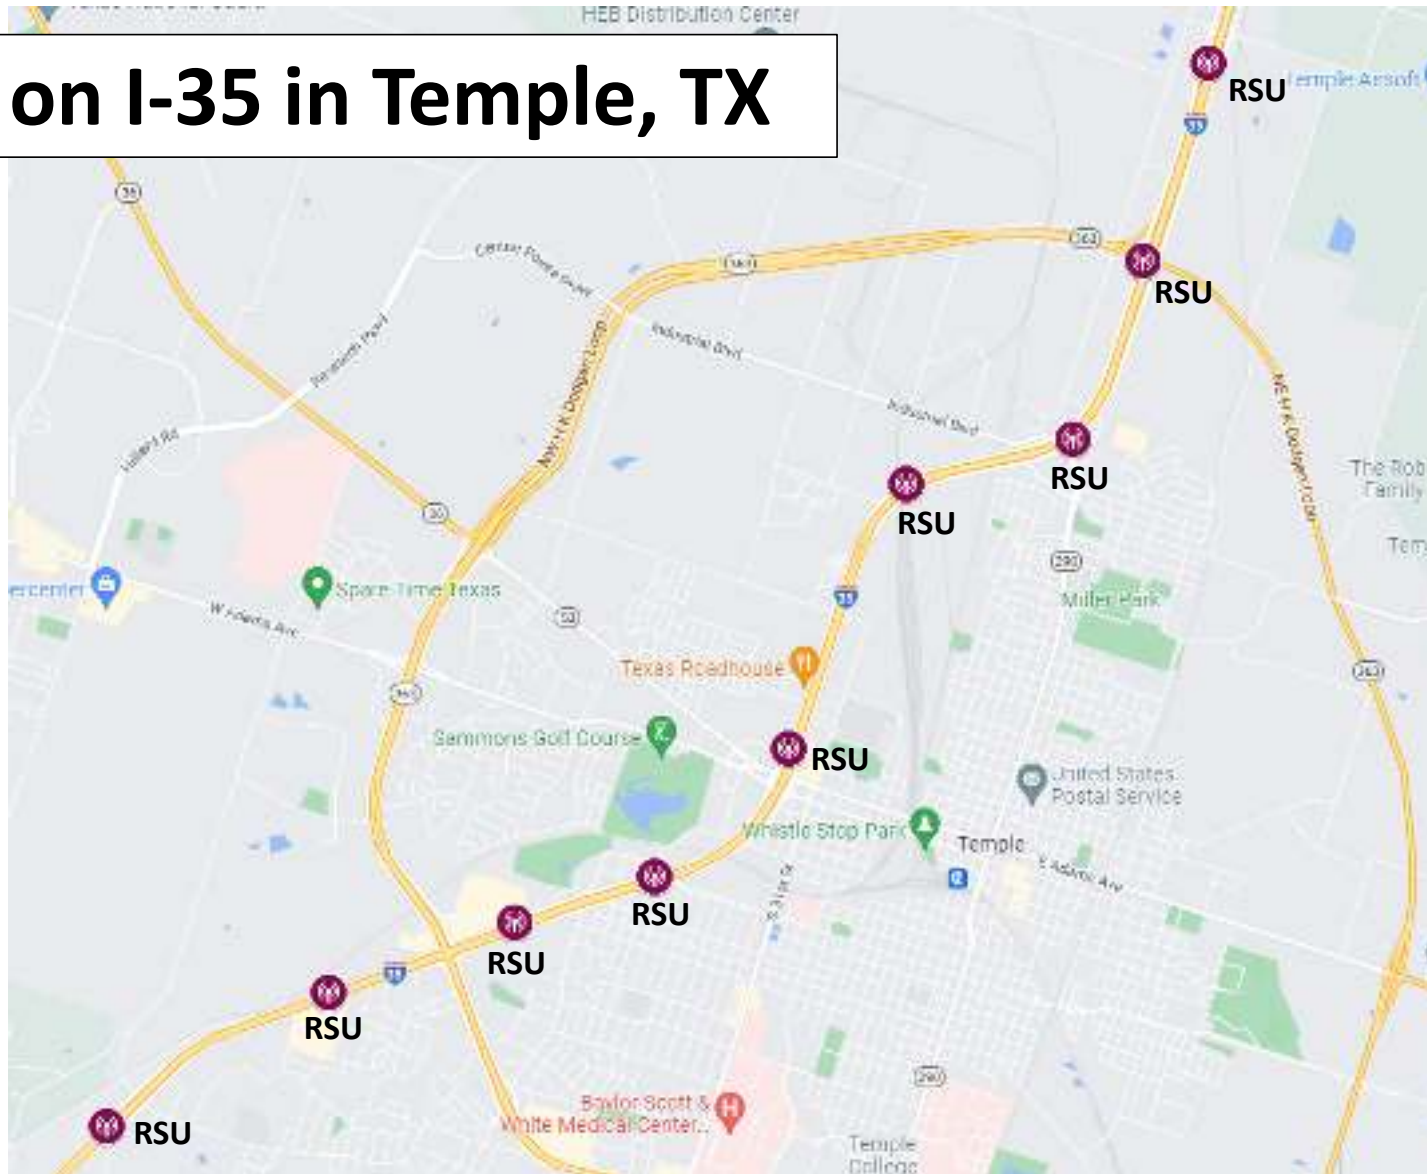
RSUs on I-35 in Temple, TX

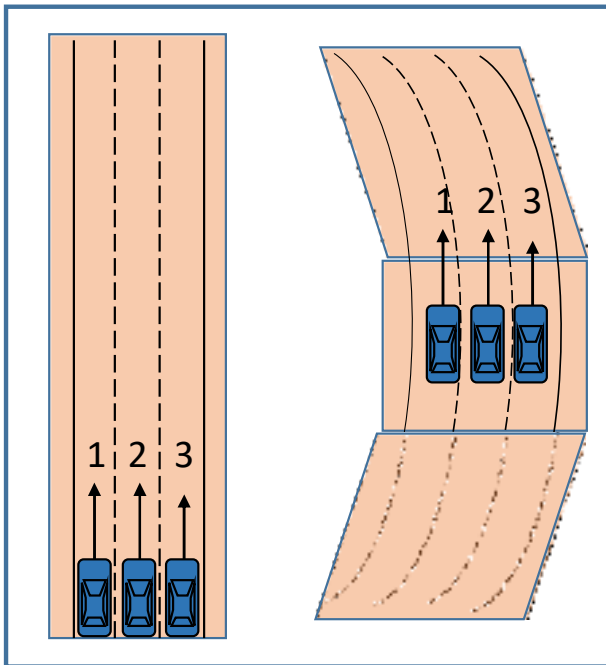
In different lanes

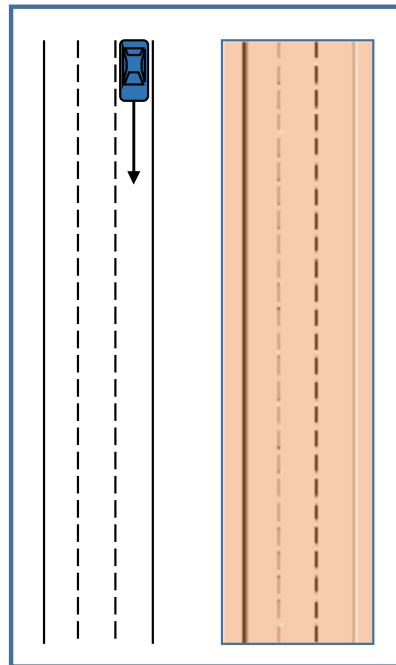
In opposite direction

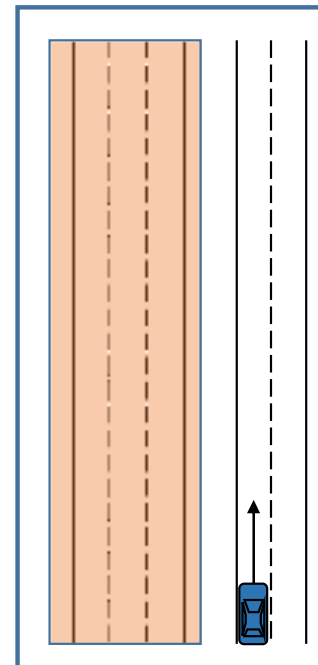
On frontage road

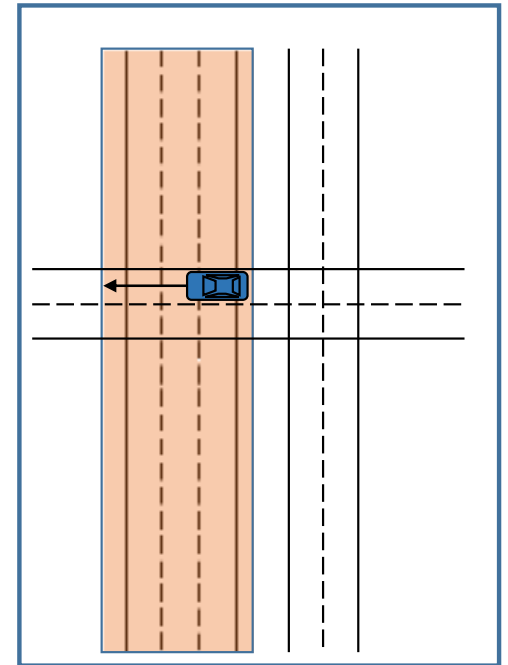
On cross-road
